# ***PRIAS***<sup>®</sup>

## **Power Rail Intelligent Analysis System**

# Conductix Wampfler *PRIAS*®

## Analysis of 3<sup>rd</sup>, 4<sup>th</sup> and AC Rail Systems

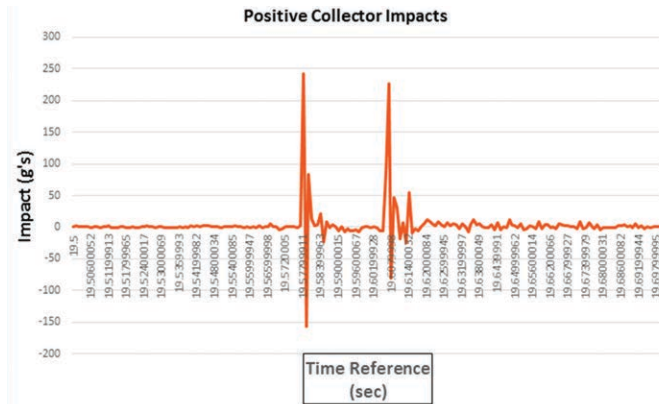
### Positive Collector Impact

PRIAS can capture rapid, short duration collector bounce, impact, and arc flash. Collector impacts increase wear and tear on shoe gear. Collector bounce interrupts current flow (power loss) while producing electrical arcs damaging to power rail and collector shoes.

The table and graph below show actual collector impact data. When merged with precise positioning information, critical collector impacts can be mapped (shown below), directing maintenance teams to problem areas.

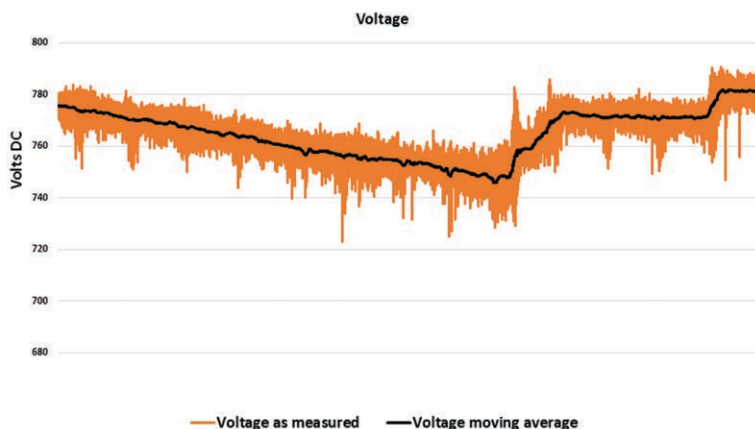
## Voltage Histogram

Voltage variation due to location and vehicle demand is common along power rail systems. PRIAS helps identify out-of-specification voltage variations. Comparison of raw voltage data with moving average data discriminates between noise and spurious signals from prolonged voltage events. Customer specified thresholds ensure accurate voltage assessment.

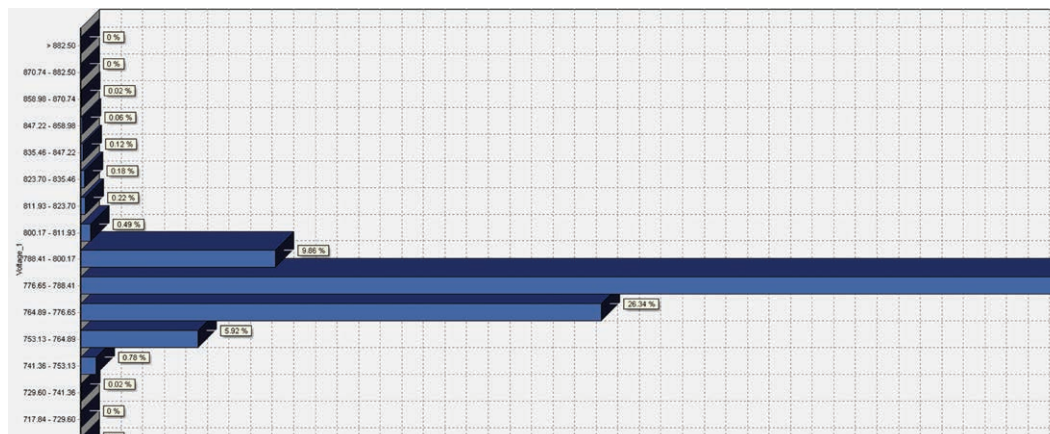
## Voltage Segment Map

Mapping system voltage to predicted voltage can identify areas of excessive resistance due to loose power rail splices or excessive current leakage at insulators. Directing maintenance teams to specific problem areas before critical failures occur maximizes the effectiveness of your limited maintenance resources and time windows.

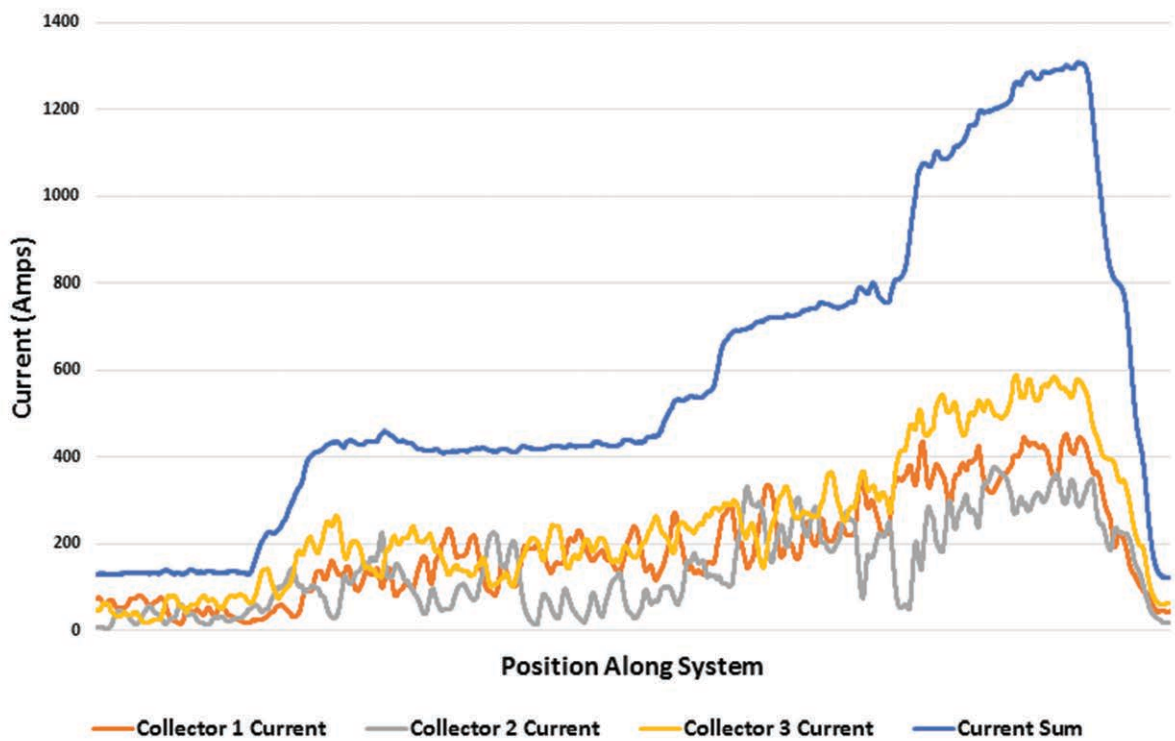
Current Collector Map: Current Versus Location

PRIAS provides individual collector and complete vehicle current. This indicates current balance between collectors, as well as individual collector current load, and total vehicle current demand. Mapping excessive current demand to position may

direct maintenance personnel to areas of excessive electrical erosion of the 3rd rail. Current histograms provide insight to current demand on a system loop or specific area of track.

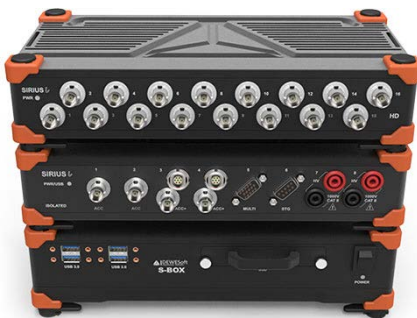
**PRIAS compact unit** (11" x 11" x 6"/280mm x 280mm x 150mm)

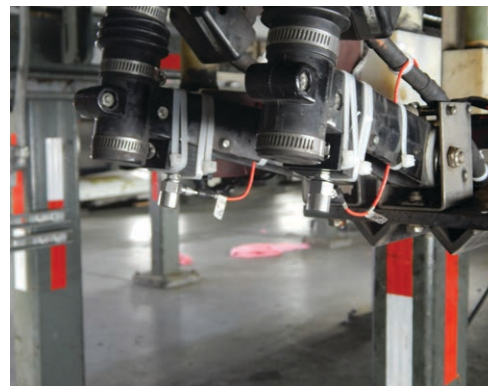
**Collector arms with accelerometers attached**

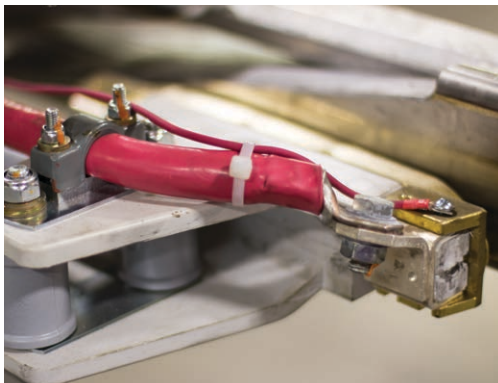
**Voltage Sensor**

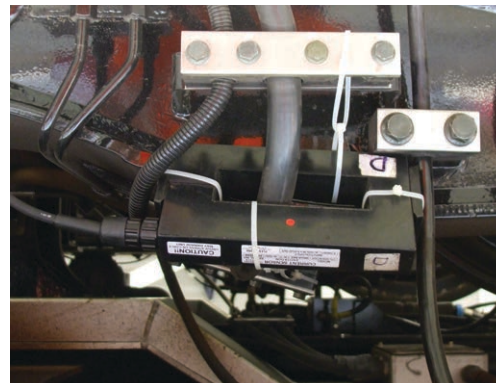
**Current Sensor**

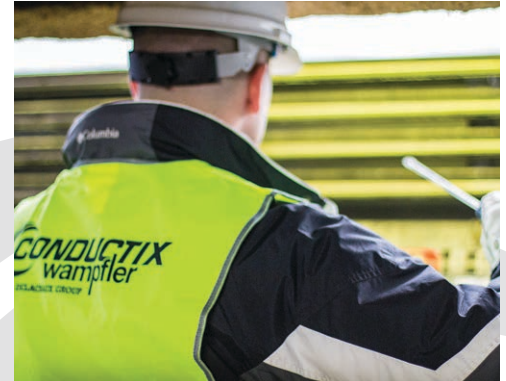
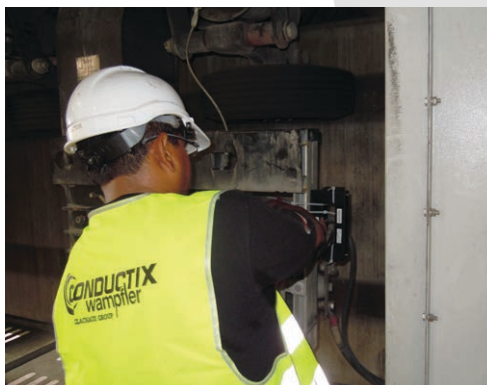
### Case Study #1

**Problem:** Power rail had become severely and prematurely damaged in several locations due to electrical erosion.

- Too few collectors for current demand.  
**Solution:** The customer added the necessary collectors.
- Severe electrical erosion on the downtrack side of a power rail isolating gap due to vehicle acceleration.  
**Solution:** The power isolating gap was repositioned to a location of vehicle deceleration.
- Overall peak current demand of the vehicle exceeded the power rail specification.  
**Solution:** The vehicle speed/acceleration profile was modified to bring peak current within specifications without affecting revenue timing/headways.
